RAILROAD ACCIDENT REPORT

DERAILMENT OF AMTRAK TRAIN NO. 1
WHILE OPERATING ON THE
ILLINOIS CENTRAL RAILROAD NEAR
SALEM, ILLINOIS

June 10, 1971

REPORT NUMBER. NTSB-RAR-72-5

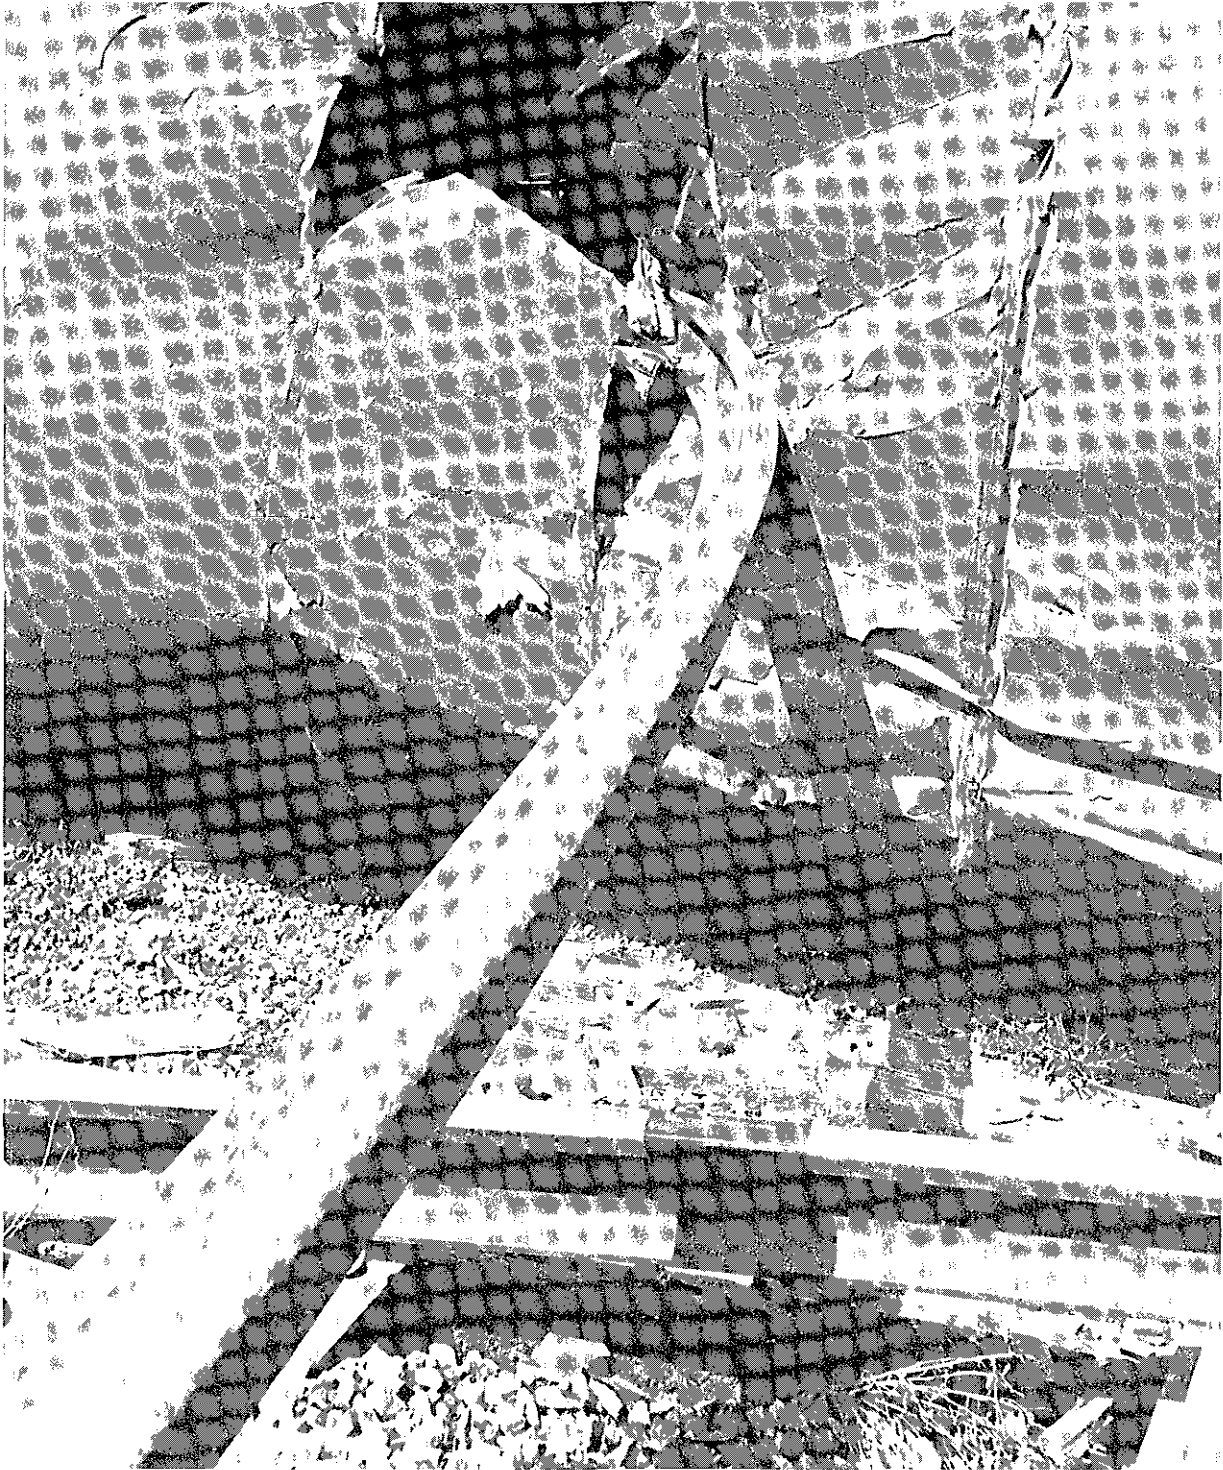
Figure 6 – Rail Penetrated Interior of Car

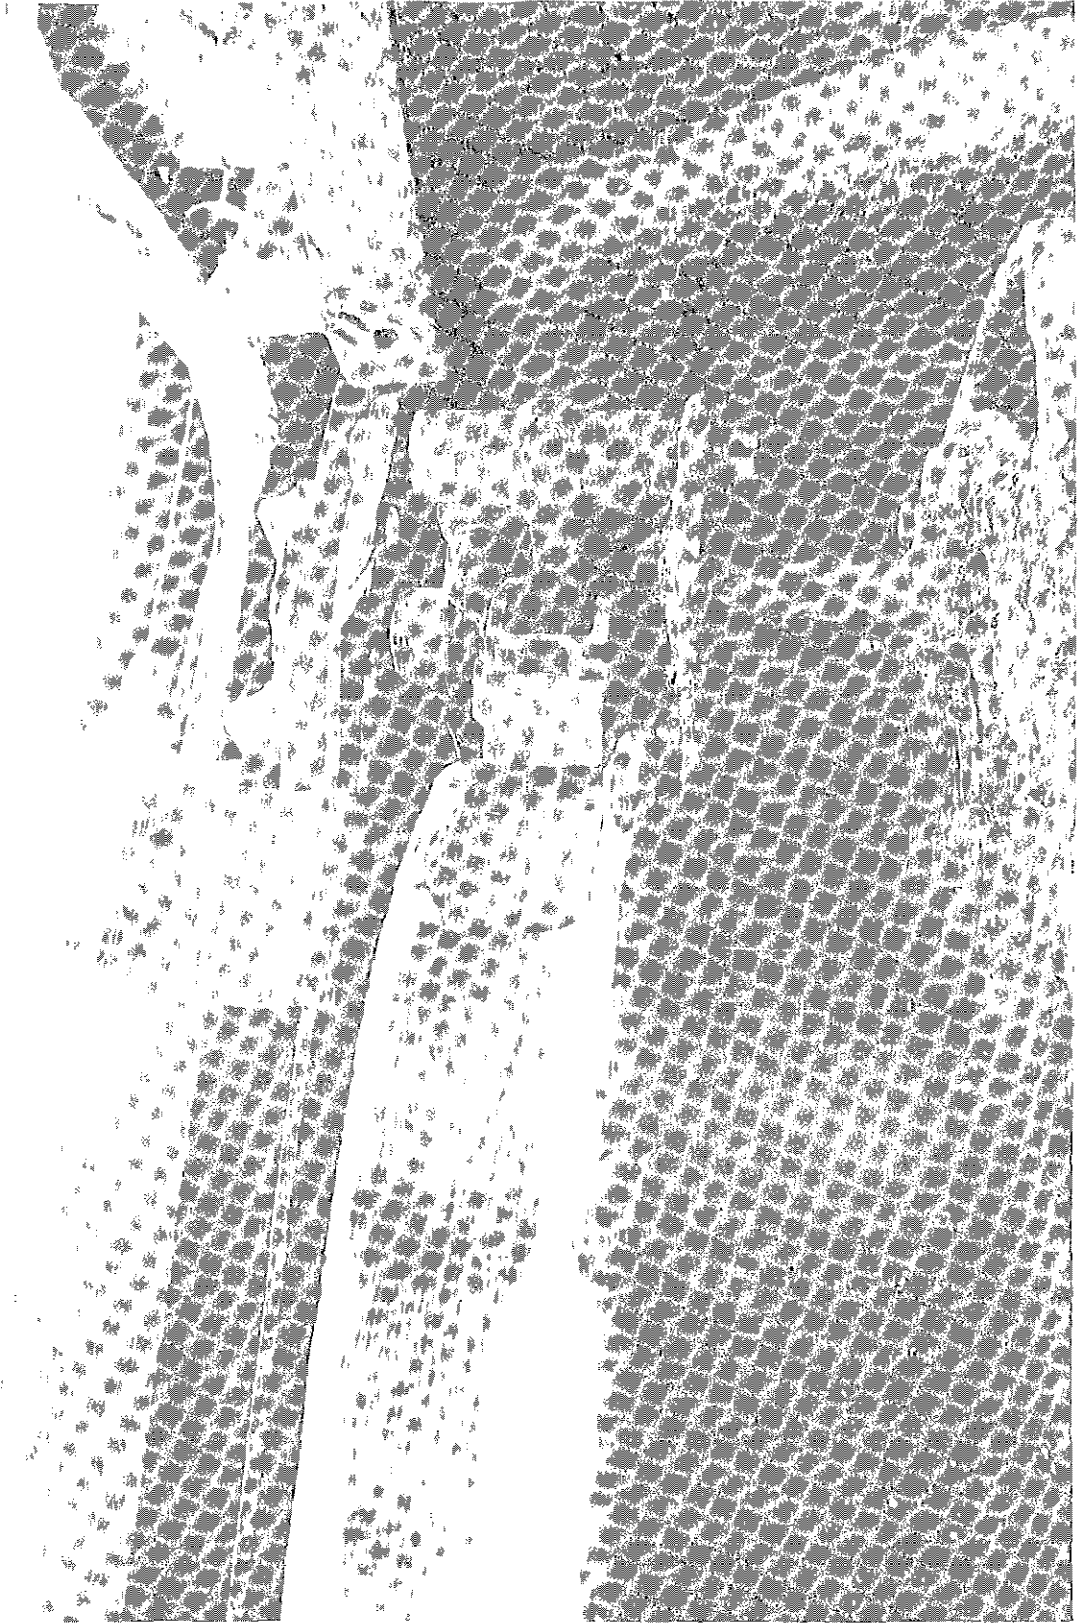
The rear truck of unit 4031 remained attached to the unit when it was turned over on its side. Both of the leading wheels of this truck had flat spots about 10-3/4 inches in length. These flat spots had produced a false flange on the outside edge of the tread. (See Figure 7.) The fact that there were no other flat spots on the wheels indicated that the wheels had not turned after locking. When the gearcase cover was removed, no broken gear teeth or other defects in the gears were found which would have caused the wheels to lock.

Figure 7 —Slid-Flat Spot on Locomotive Wheel as Observed at Scene of Accident.
Gear Case has been Removed.

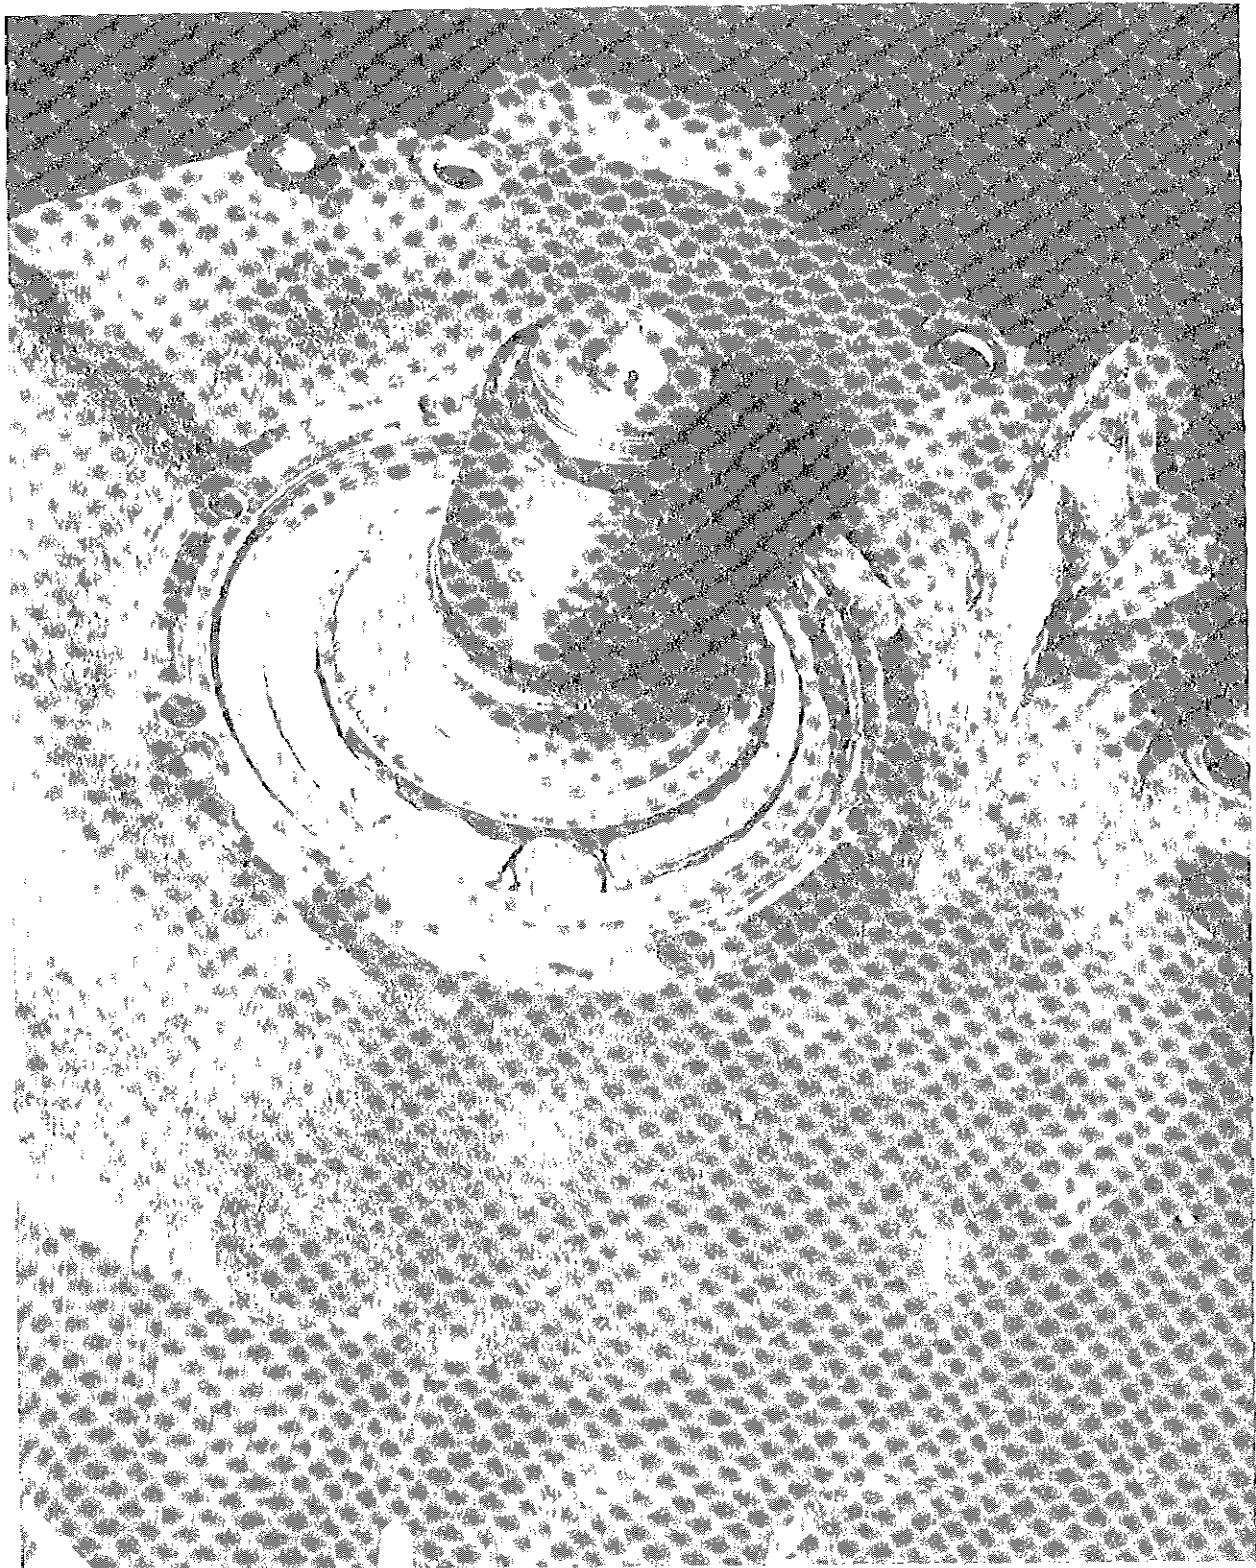
The armature was removed from the motor and disassembled. The commutator end roller bearing was damaged by heat and the grease was charred. (See Figure 9.) The pinion end roller bearing was damaged by heat. The steel rollers were flattened, grooved, and discolored. The inner and outer races were damaged. (See Figure 10.)

Figure 10 – Damaged Pinion End Bearing

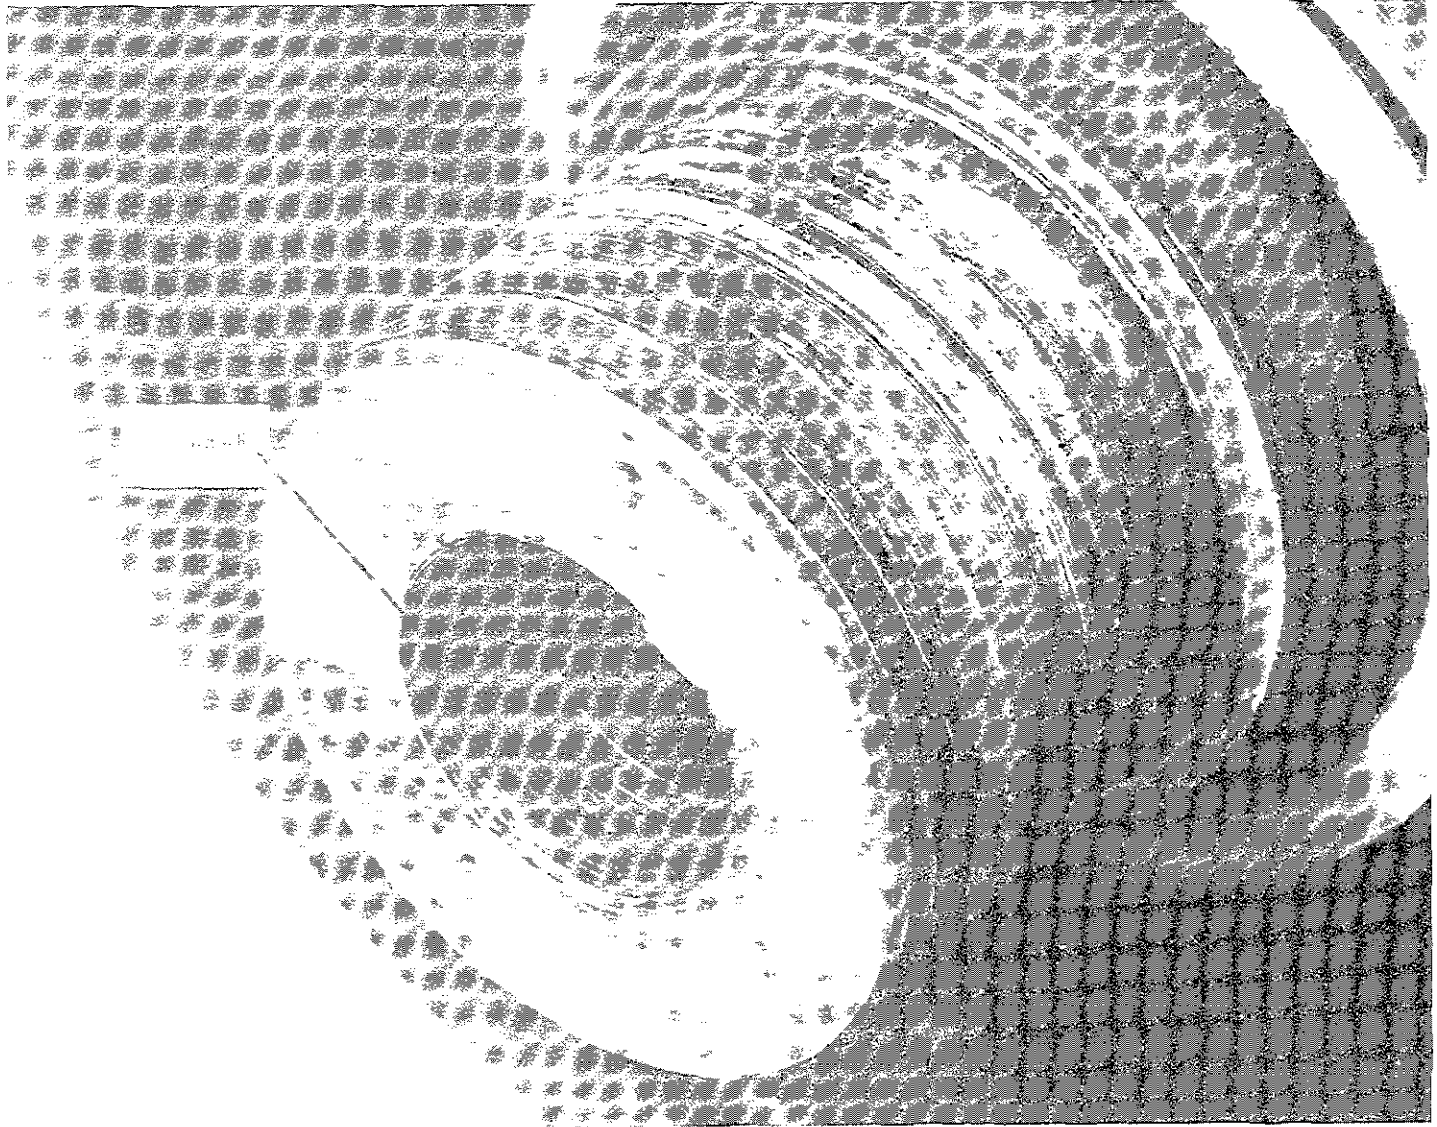
Figure 11.--Commutator End of Armature Shaft showing markings made by set Screws with no Evidence of Set Screws moving on Face of Shaft.

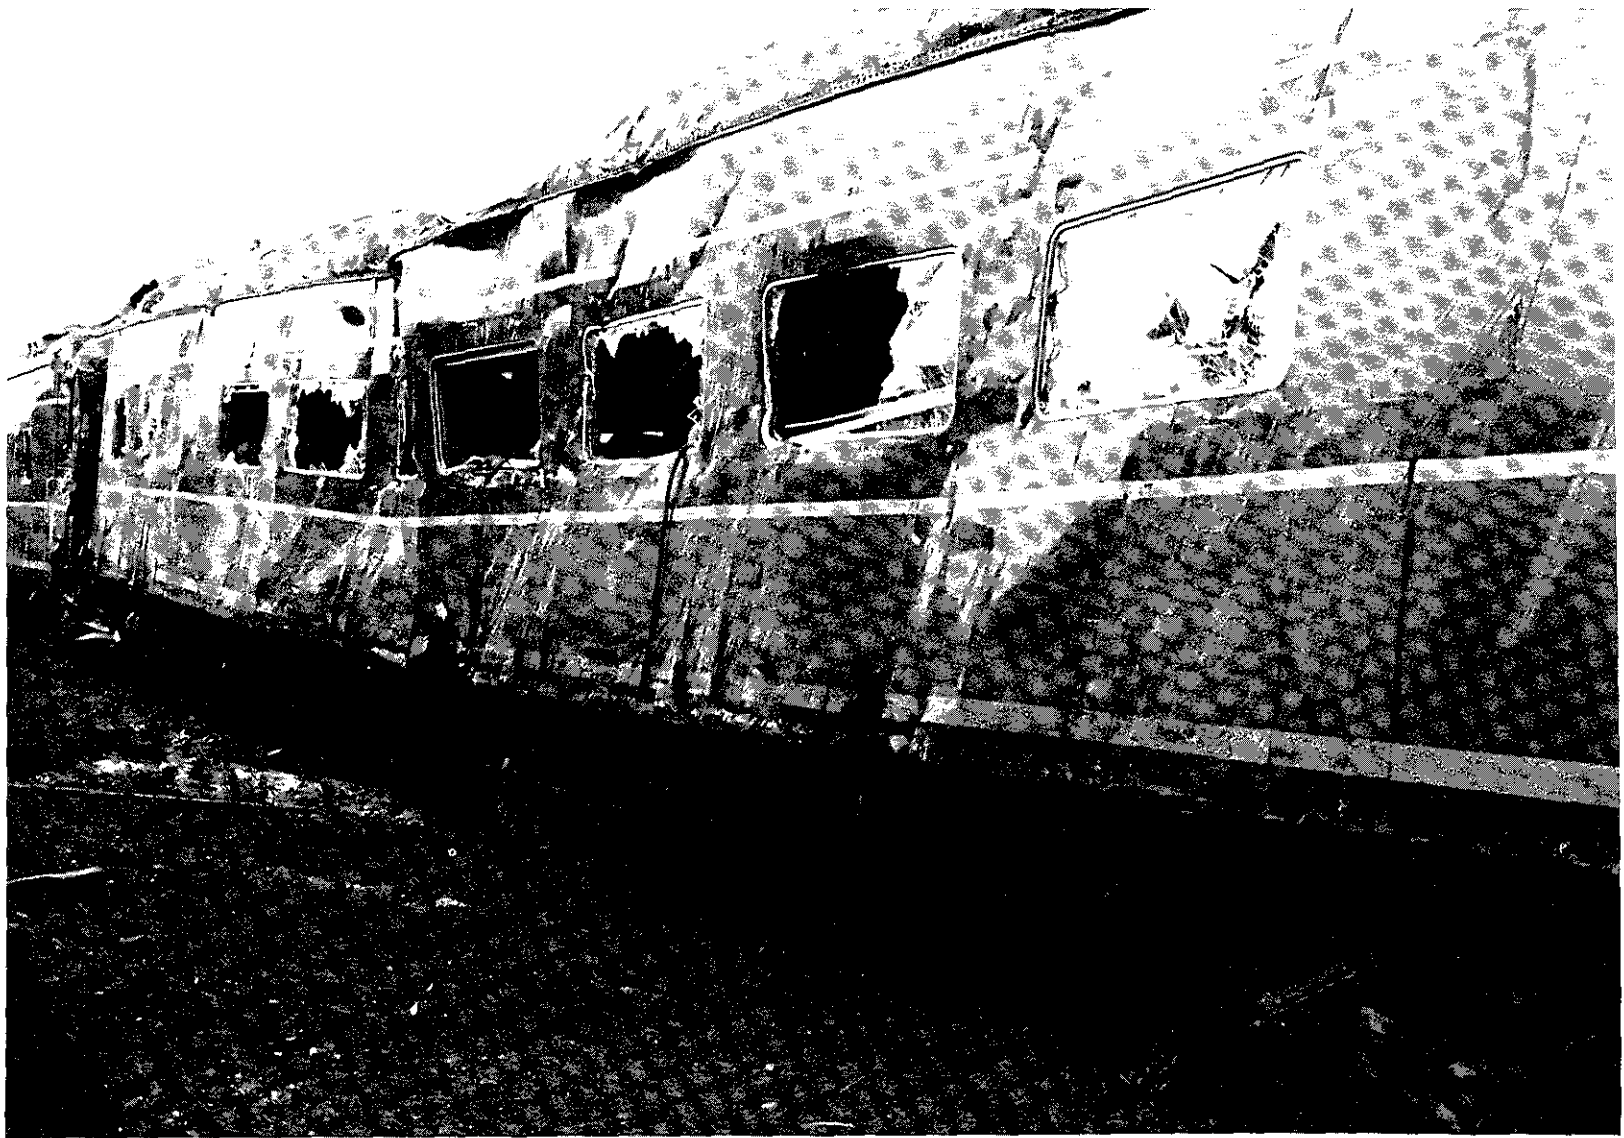
Figure 12.—Large observation type windows broken out when car 2616 overturned. Note outward distortion of broken glass in two nearest windows. The broken out windows became the floor of the passenger compartment as the car slid to a stop. At least one or as many as three passengers were ejected through these holes and were fatally injured.

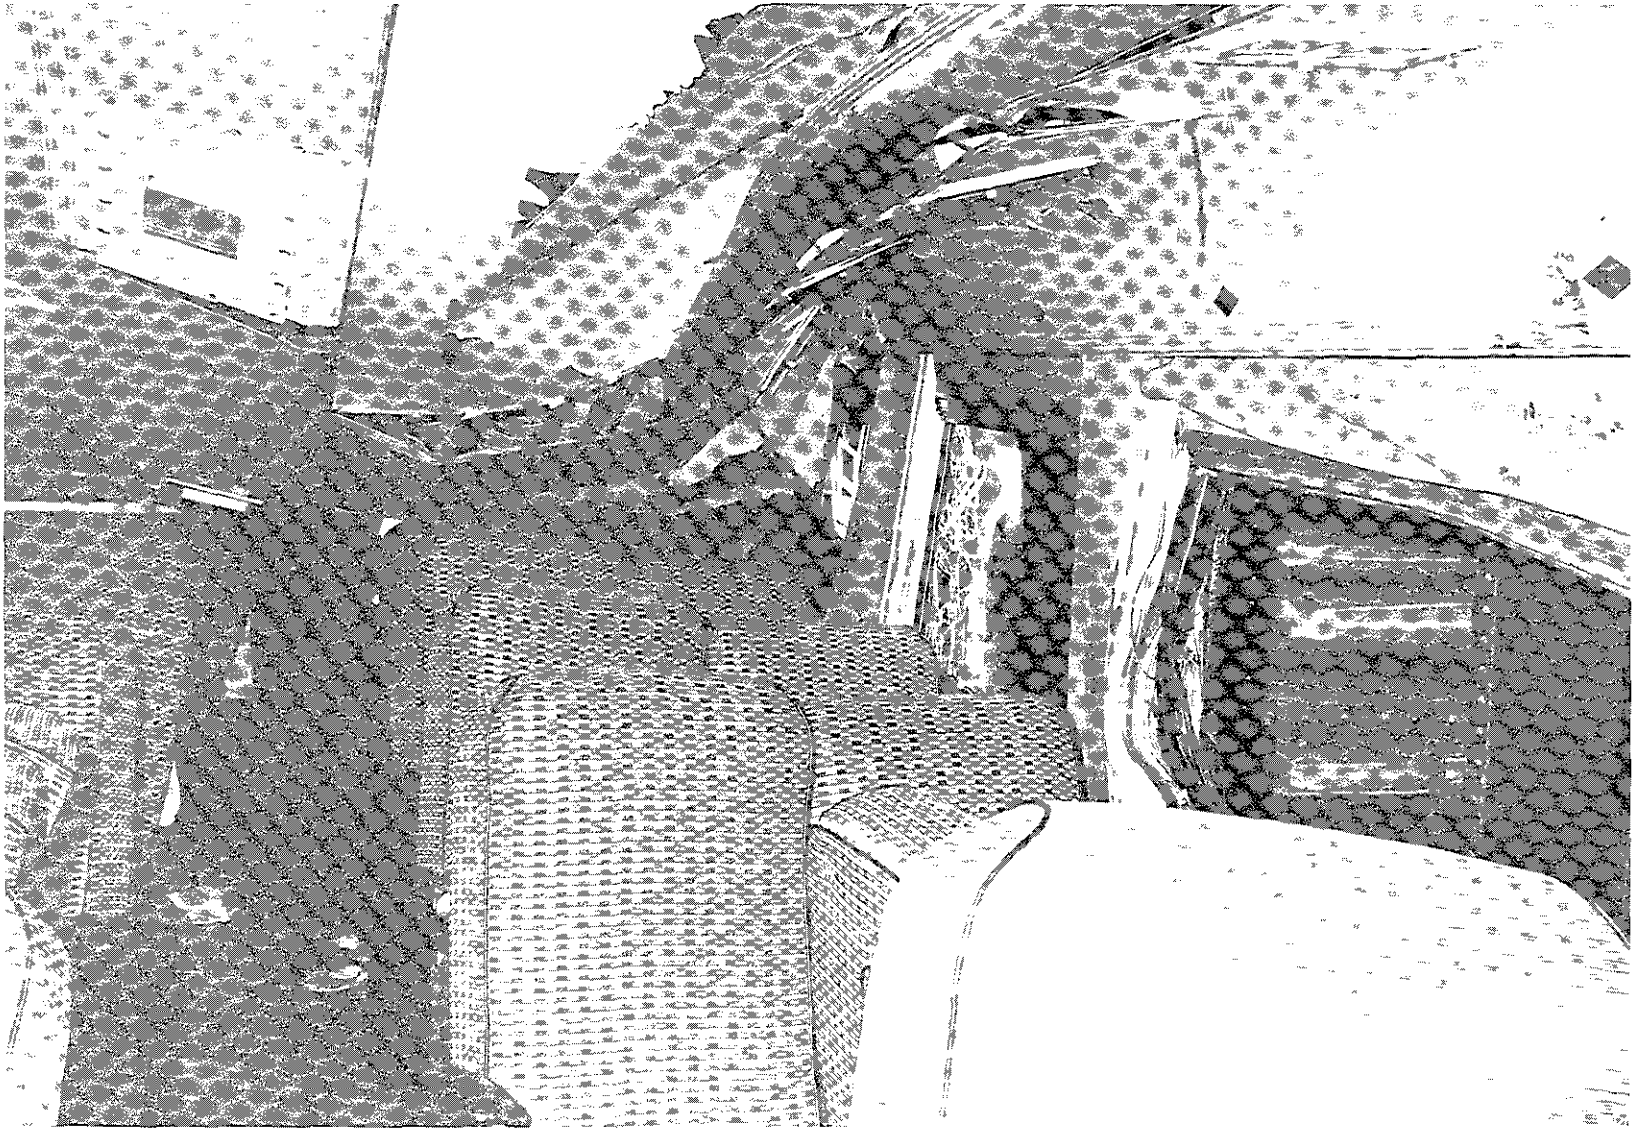
Figure 13.—Separation of metal ceiling which produces sharp edges.

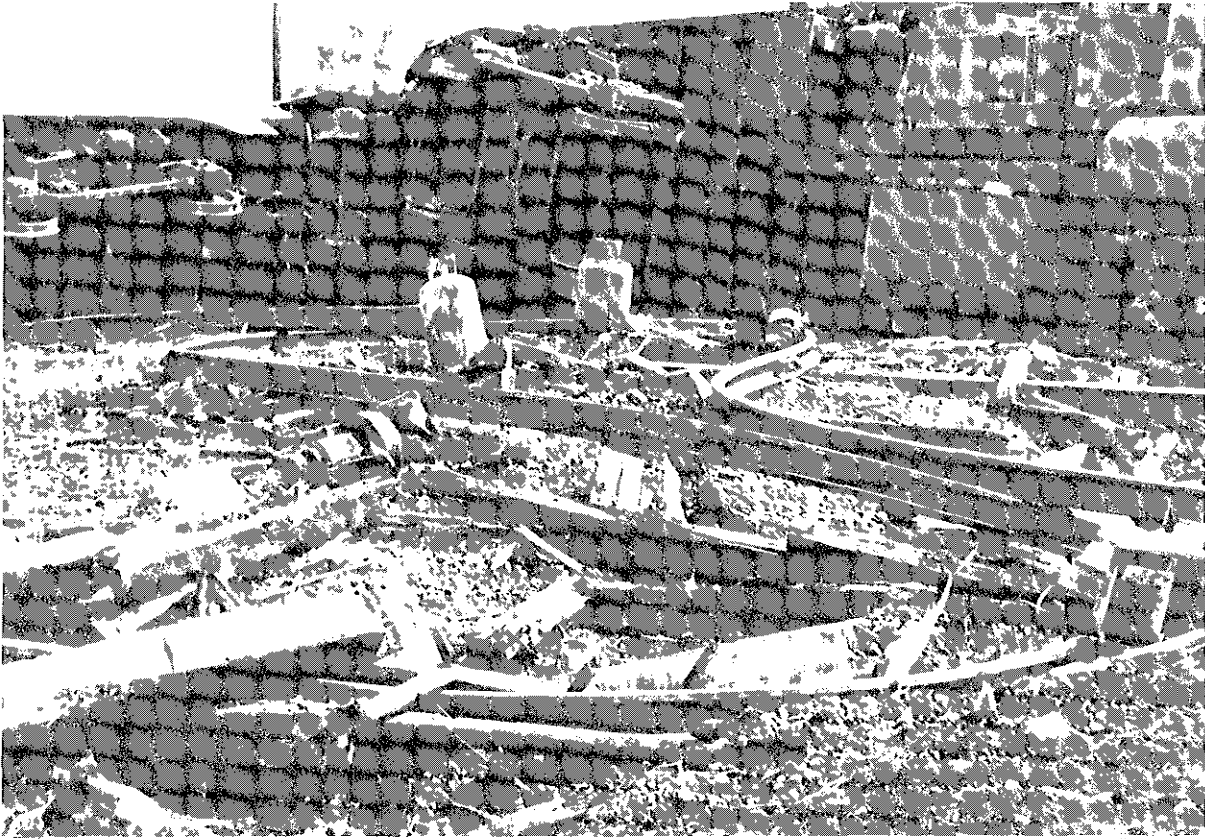
The first six cars were demolished. Their sides were bent and torn, their underframes were damaged, and the roofs of several of the cars were smashed downwards. Most of the windows on the sides of the cars which were in contact with the ground were smashed. Many of the seats in the coaches had rotated and some were torn loose from the floor. Unsecured furniture in the coaches, particularly in the dining cars, was thrown around the interior of the cars. Broken rails from the track penetrated several cars. In one case, a rail was driven up through the floor in the seat area and in another case a rail penetrated the toilet area. (See Figure 6.) Propane tanks on some cars were torn loose and were scattered on the ground, whereas the fittings of others were torn loose. The propane, however, did not ignite.

Figure 15 – Views of Damaged Propane Cylinders

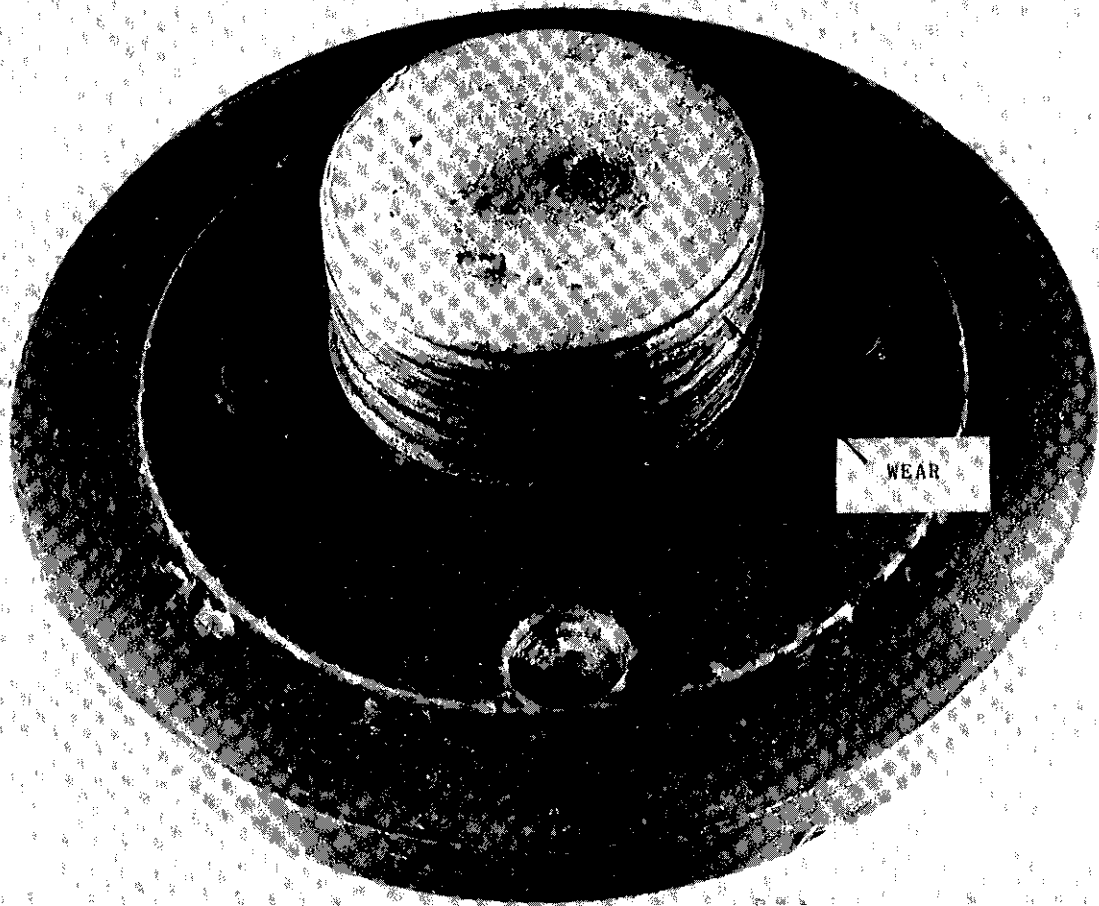
**Photograph 1D –Inner Face of Locking Plate Showing worn threads and
Lack of wear on outer edge where Plate should Contact H-Ring.**

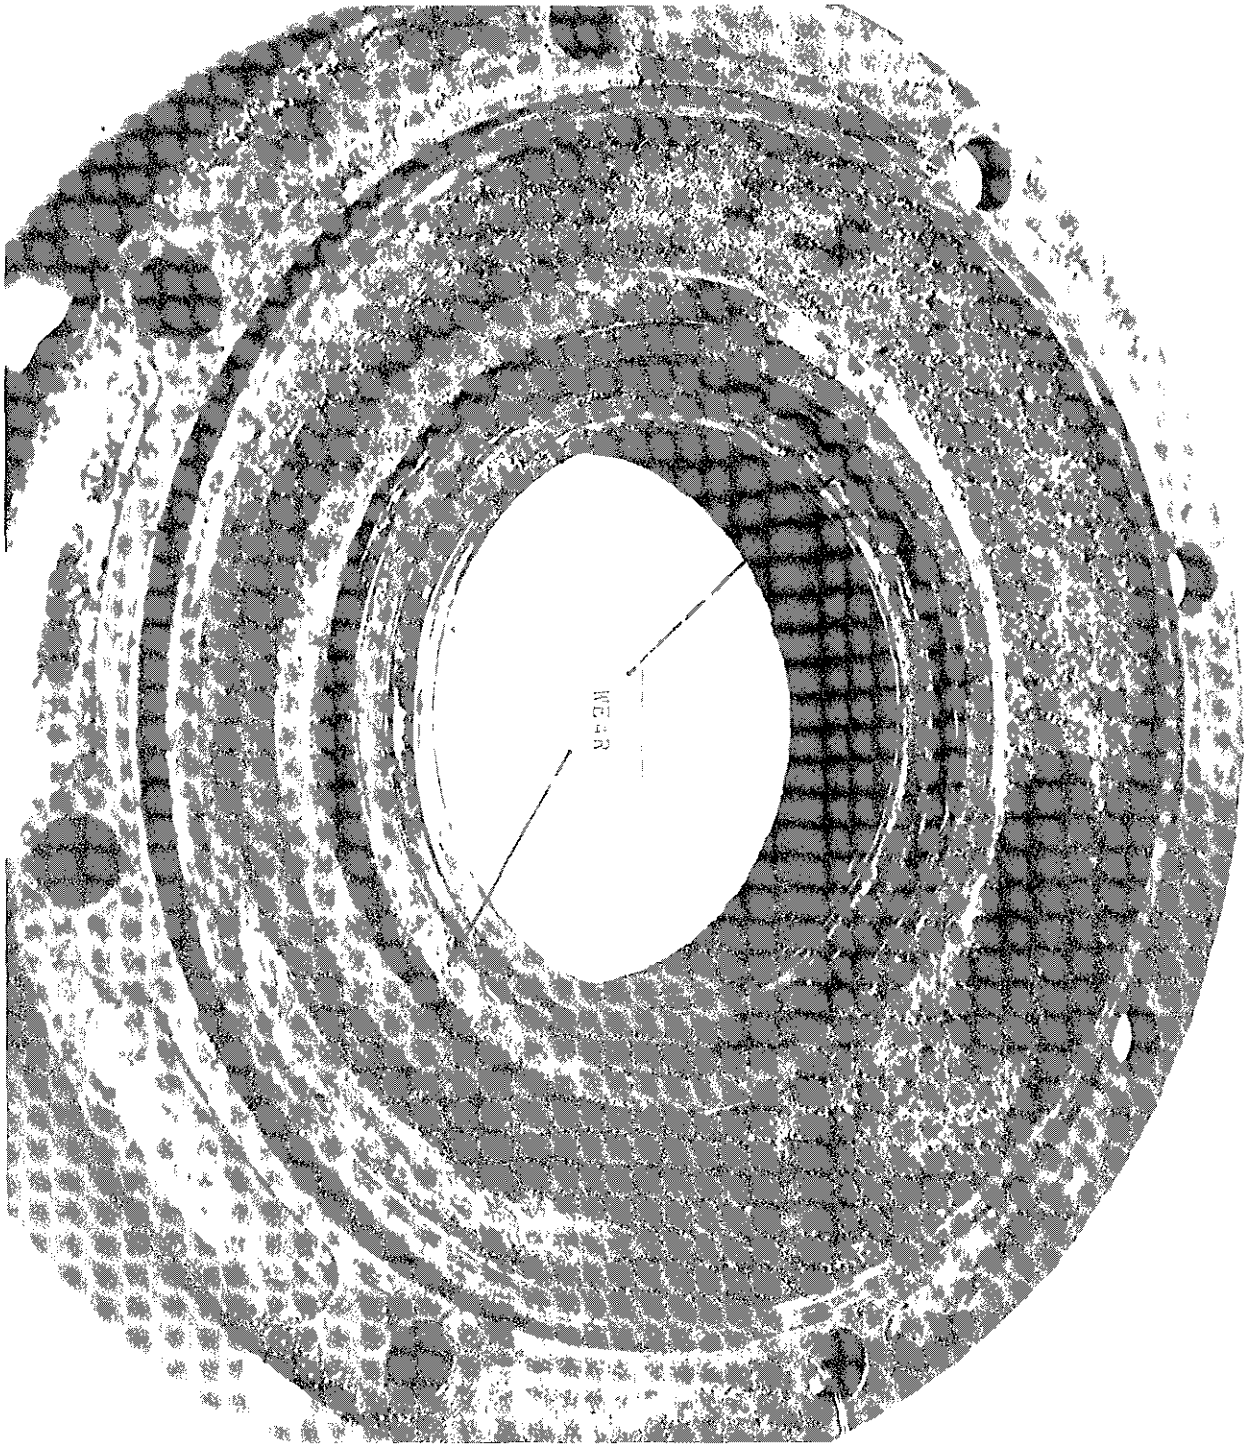
**Photograph 2D.—Pinion Bearing End Cover Showing Excessive Wear from Contacting
Outer Oil Thrower**

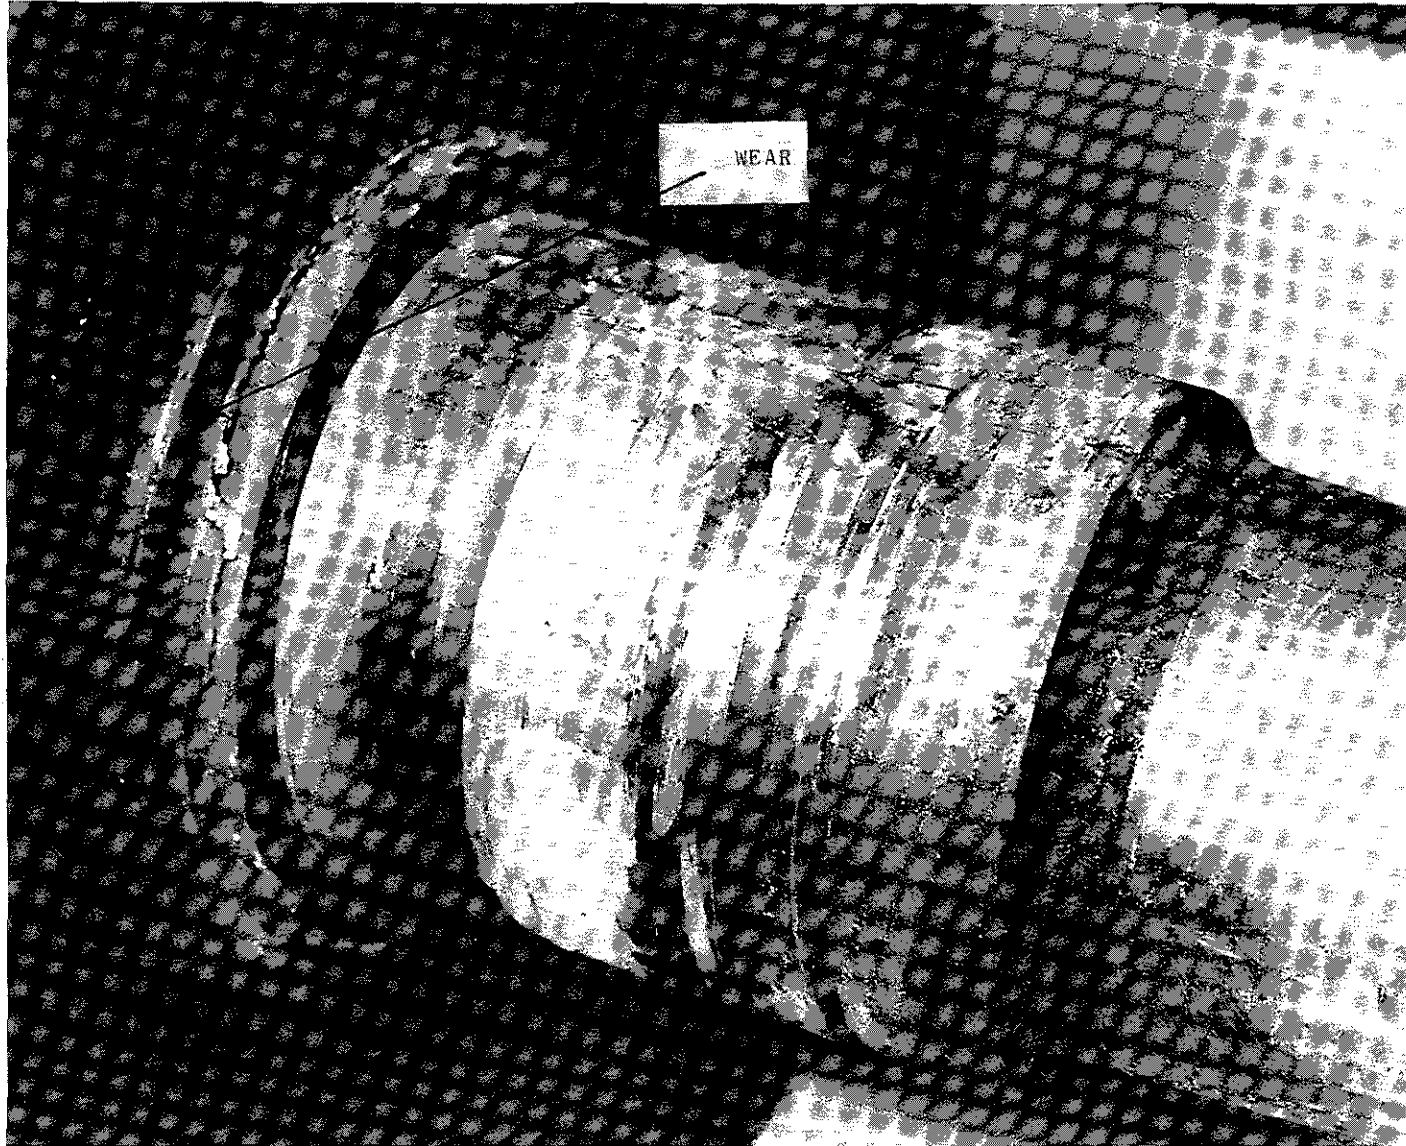
Photograph 3D.—Pinion End of Armature with Bearing Removed, Note Excessive Wear on Oil Thrower

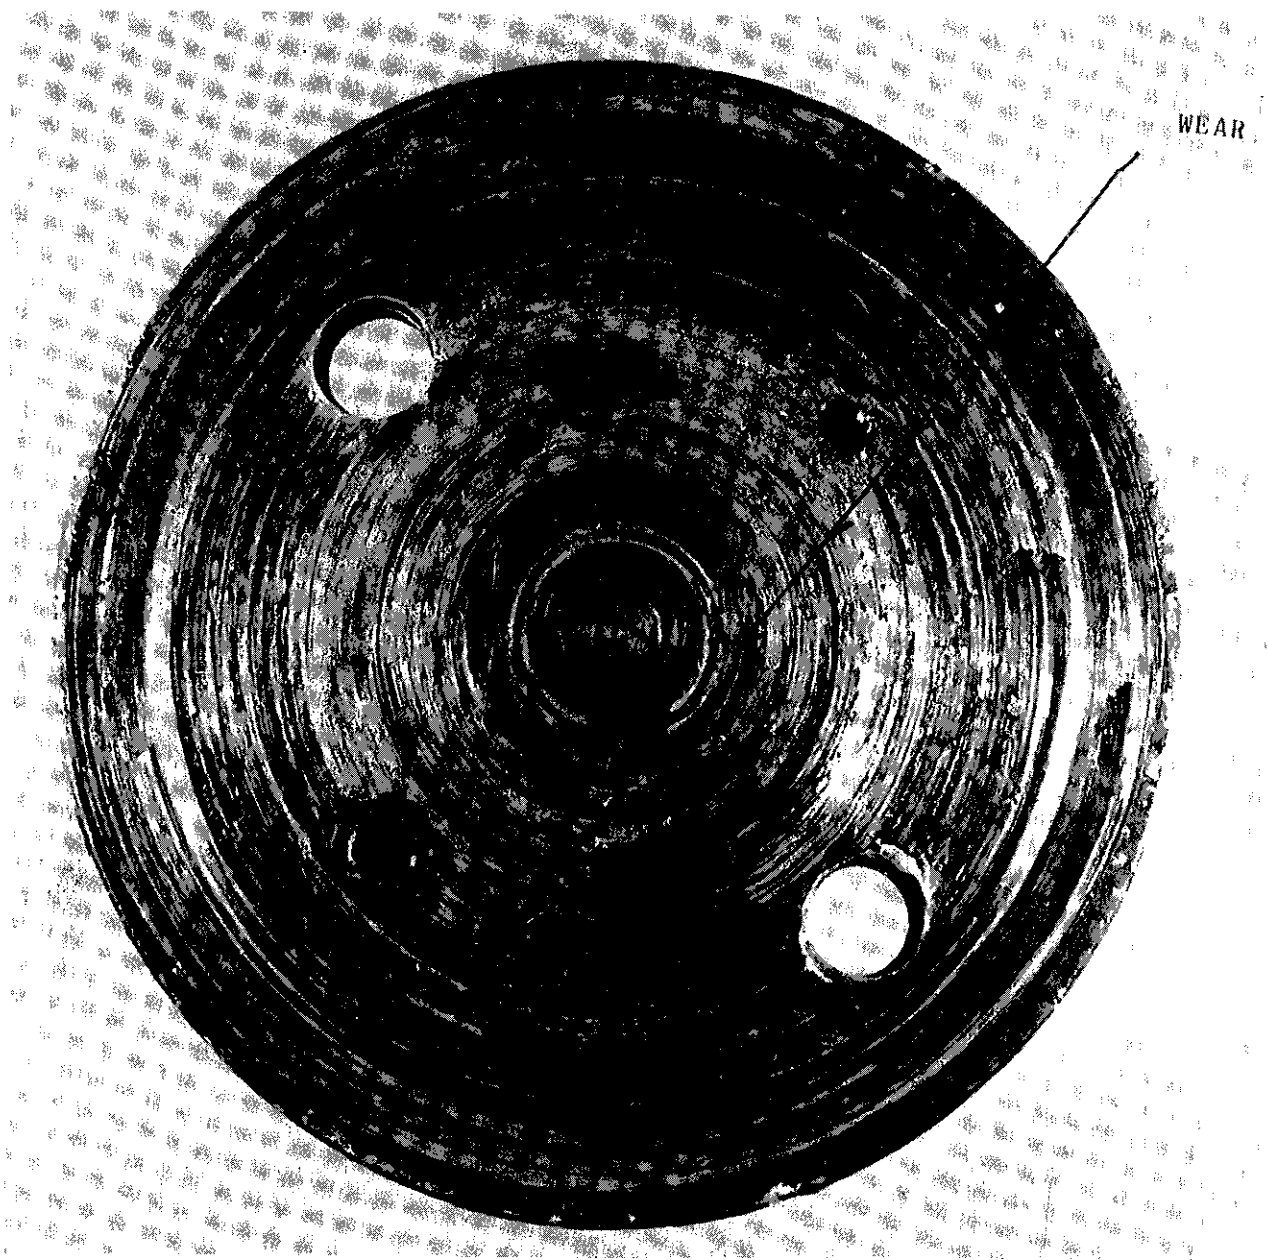
Photograph 5D.—Outside Surface of Locking Plate showing Wear due to Plate Contacting the Commutator Bearing End Cap.
