PB94-916301  
NTSB/RAR-94/01

# NATIONAL TRANSPORTATION SAFETY BOARD

## RAILROAD-MARINE ACCIDENT REPORT

DERAILMENT OF AMTRAK TRAIN NO. 2  
ON THE CSXT BIG BAYOU CANOT BRIDGE  
NEAR MOBILE, ALABAMA  
SEPTEMBER 22, 1993

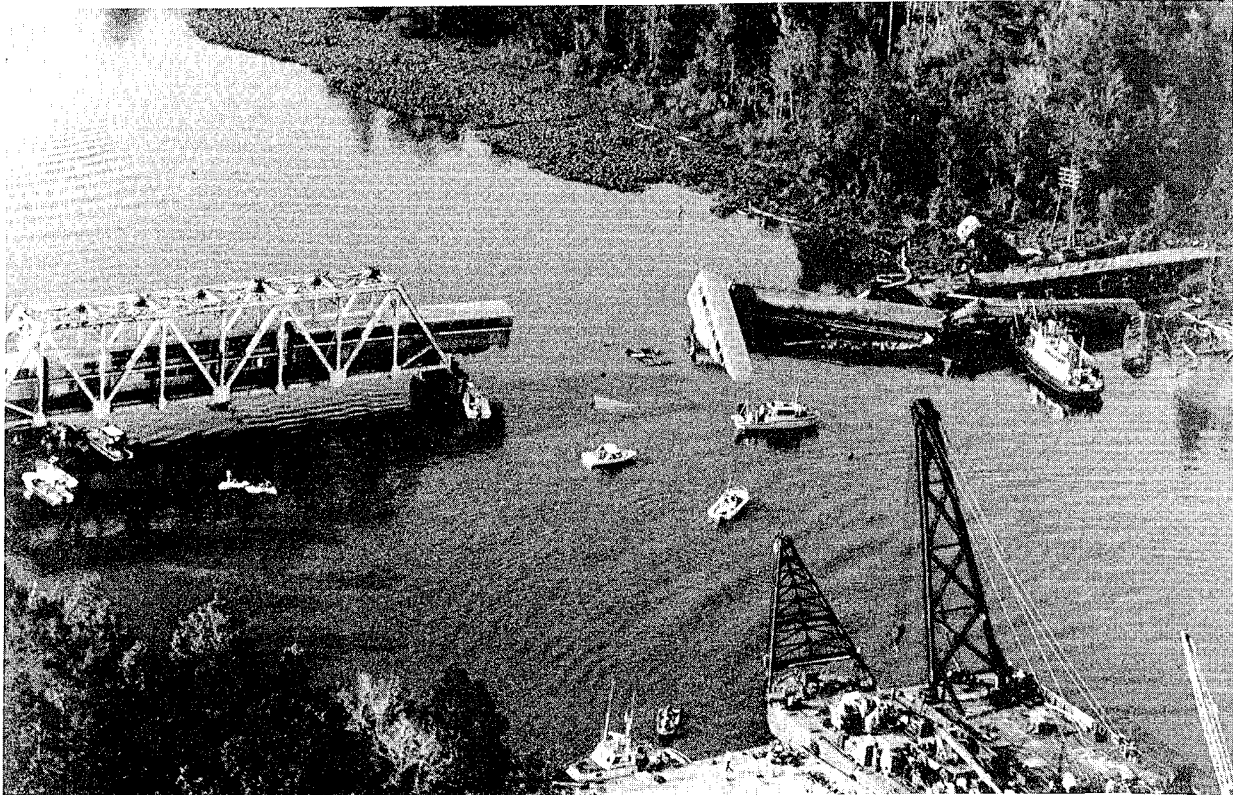
The conductor described the trip from Mobile to the accident site as uneventful. He said the locomotive crew called all signal indications over the radio, and he repeated them over his portable radio.<sup>8</sup> According to the assistant conductor, he last talked with the locomotive crew before the accident when the engineer called to thank him for bringing coffee at Mobile. The assistant conductor last remembered the locomotive crew calling the signal at Bayou Sara, mile post (MP) 658.4; the call was "clear" and the conductor repeated it to them shortly before the derailment. The train accelerated toward the Big Bayou Canot bridge and, traveling about 72 mph (authorized speed was 70 mph), struck the displaced bridge girder and derailed at MP 656.7 about 2:53 a.m. (see figure 5).

**Figure 5.--Photograph of accident site.**

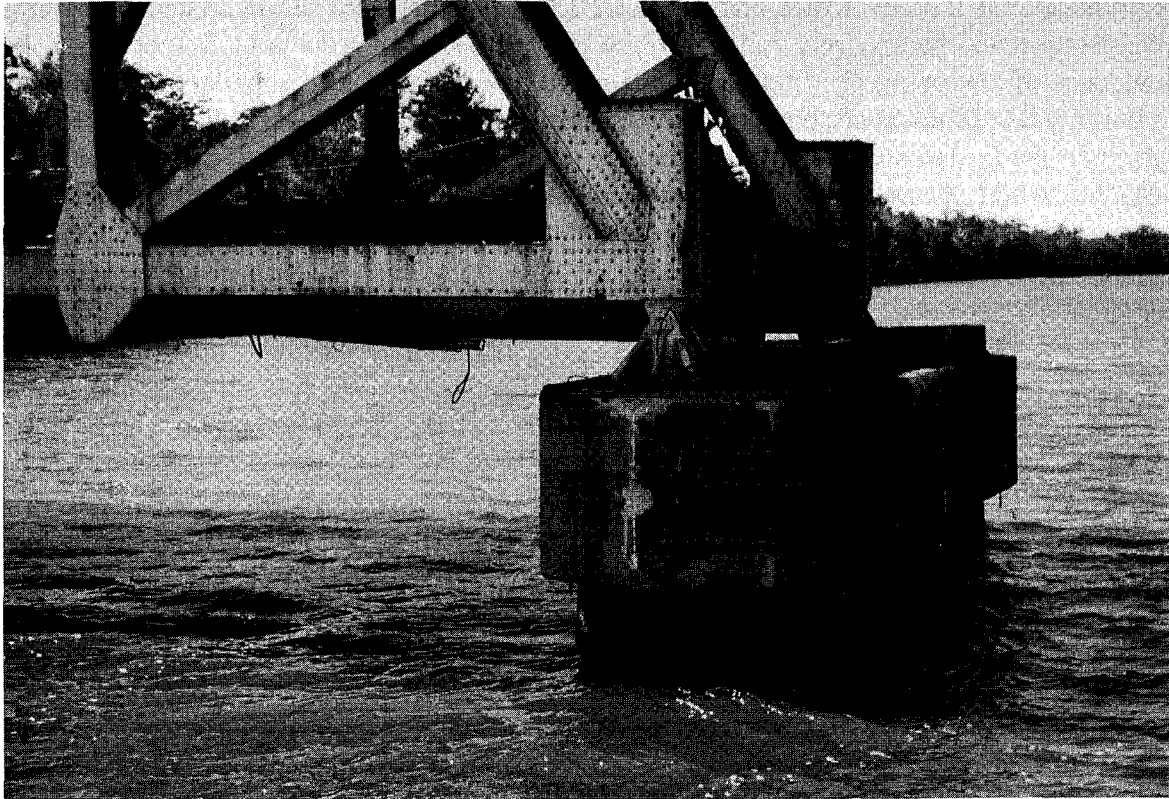
The nose of the south pier sustained some concrete spalling (chipping or scaling) from the MAUVILLA's lead port barge (see figure 7). The east edge of the sole and filler plates for the east girder's south bearing came to rest on the west edge of the east pedestal and the west edge of the pier cap plates. The west girder plates were found on the pier cap adjacent to the west edge of the west pedestal. The bottom of the east girder sole plate had large radius lateral striations (grooves or channels), and the west sole plate had straight lateral striations.

About 15 feet of the top flange of the east girder, beginning at the south girder face, was separated from the web. Part of the top of the plate over this 15-foot section was "accordianed", the rest of the top flange was comparatively undamaged. The web sustained two tears, one extending from the top to the bottom flange and a large horizontal tear between the fourteenth and seventeenth stiffeners. The bottom flange had two indentations, 21 inches and 22 inches wide, respectively, on the bottom east side.

**Figure 7.--Collision marks on Big Bayou Canot bridge.**

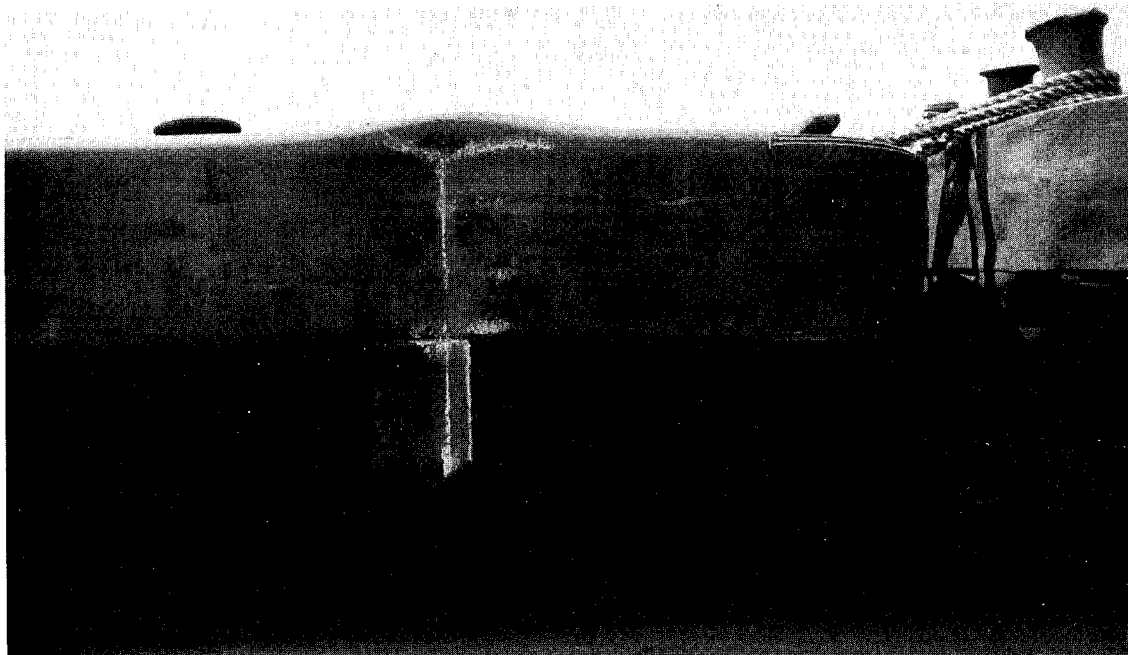
was drydocked at W&GN's yard on September 27, 1993, for a hull survey. The marine investigative group noted no apparent damage to the hull, rudders, or propellers. Inspection revealed no evidence of a wire or other item having been wrapped around the propellers or rudders. The lead port (WGN 285) and starboard (WGN 208) barges (see figure 8) were slightly dented where they struck the bridge's concrete piers, and the center lead barge (WGN 258) had six marks on its headlog where it struck the vertical stiffeners on the bridge span (see figure 4). The other three barges were undamaged.

**Figure 8.--Collision marks on barge.**
