RAILROAD ACCIDENT REPORT

DERAILMENT OF AMTRAK TRAIN NO. 1
WHILE OPERATING ON THE
ILLINOIS CENTRAL RAILROAD NEAR
SALEM, ILLINOIS

June 10, 1971

REPORT NUMBER. NTSB-RAR-72-5

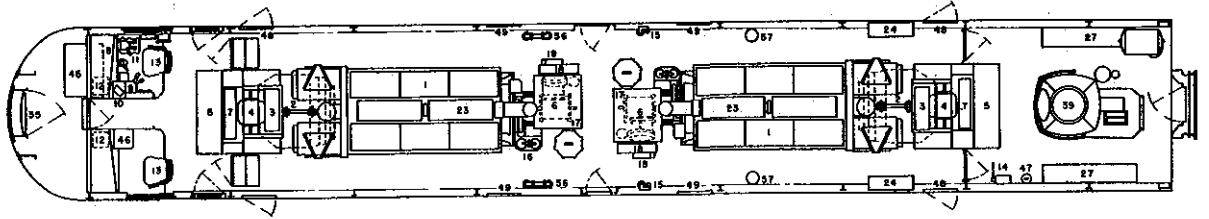
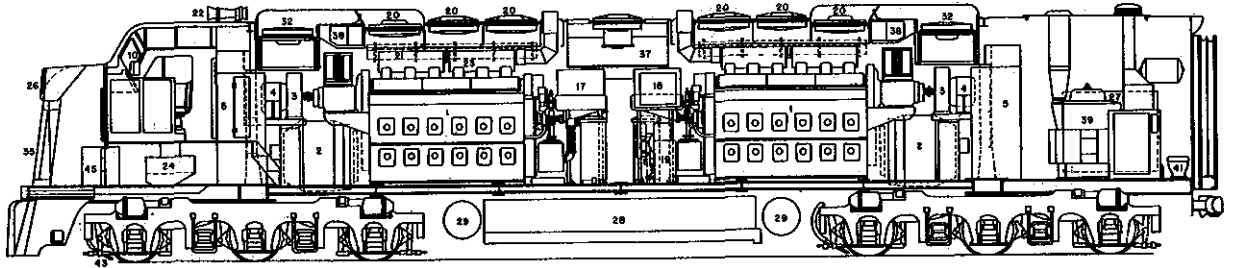
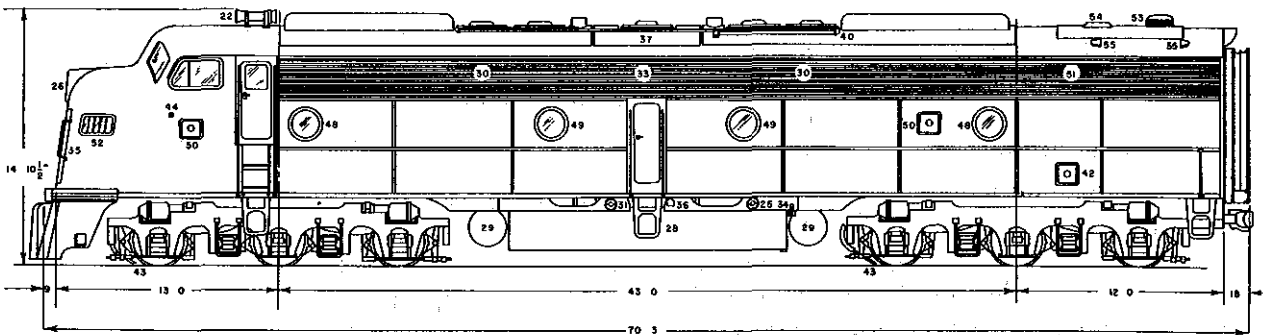
Figure 2.—Arrangement of EMD E-8 Passenger Locomotive Unit.

Diesel electric unit 4031 was an EMD, E-8A, car-body type, rated at 2,250 horsepower and built in June 1952. Its total weight was 323,320 pounds. The control compartment, located in the forward section, had a rounded nose in front of and below it. The unit had two six-wheeled roller-bearing trucks. (See Figure 2.) Each of the two outside pairs of wheels of each truck was propelled by a traction motor mounted between the axle of the wheels and a crossmember of the truck. The motor, which was supported on the axle by two friction type suspension bearings and on the truck frame by a rubber nose suspension pack, drove the wheels by means of a direct connection between a 25-tooth pinion gear mounted on the traction motor and a 52-tooth ring gear mounted on the axle. (See

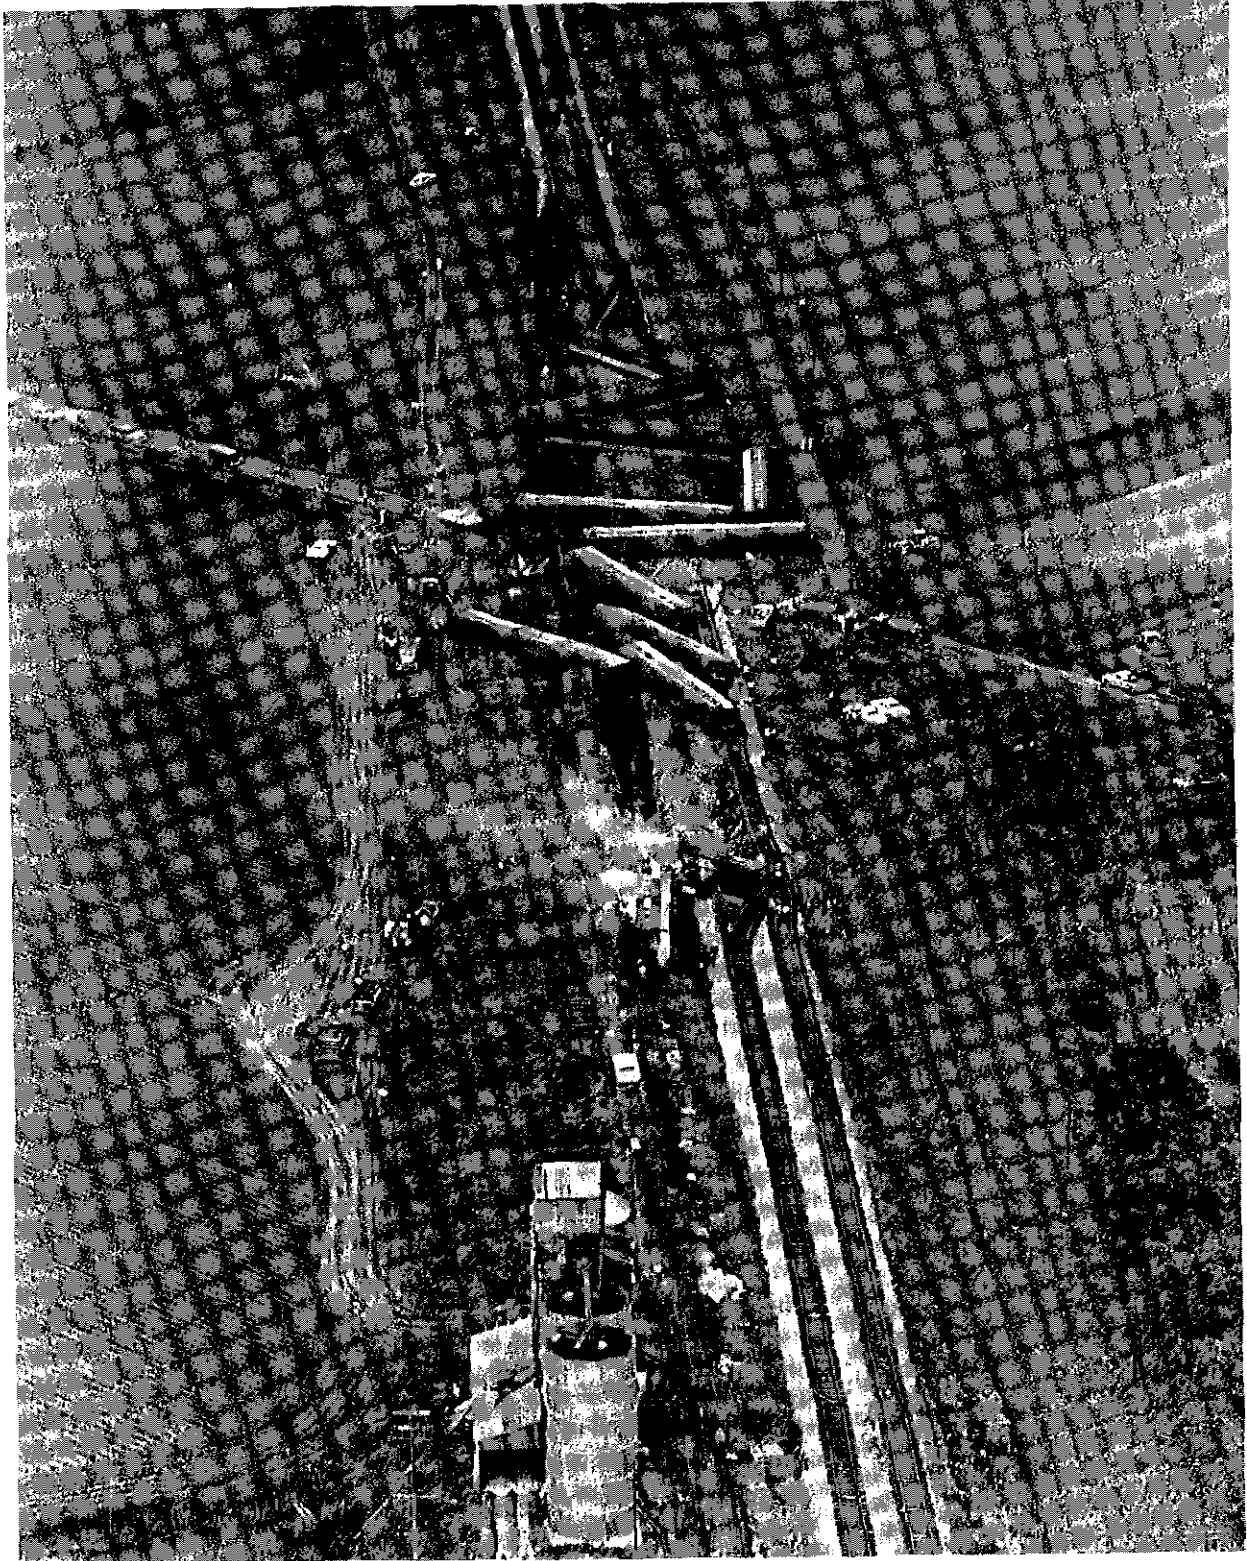
Figure 5 – The Location of the Locomotive and Cars After Derailment

The first two locomotive units stopped west of the siding with the front end of the first unit 1,031 feet south of the point of derailment. The third and fourth locomotive units stopped upright on the siding and to the rear of the second unit. The first seven cars jackknifed, turned on their sides, and stopped in various positions, as shown in Figures 1 and 5. The next five cars jackknifed but stopped upright across the main tracks. The remaining two cars derailed and stopped in line with the southward main track.

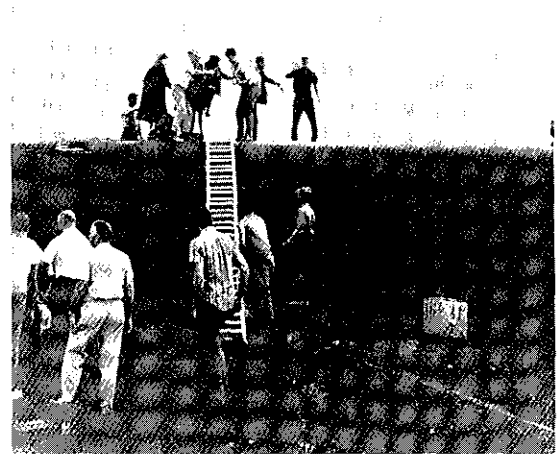
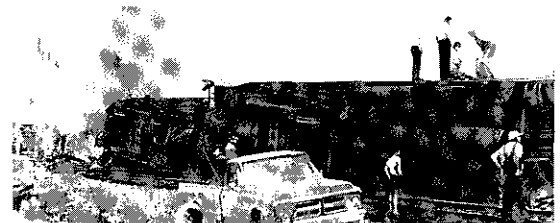
Figure 14

The bending of the roofs downwards caused the metal ceiling to separate, producing sharp edges in three of the overturned cars.⁸ (See Figure 13.) The deformation of the superstructure of the cars not only caused injuries but made rescue of the passengers extremely difficult. The passageways at the ends of the cars were either blocked or difficult to use, and with no emergency exits, the passengers had to wait until the rescue personnel could break windows on the top sides and provide ladders for climbing out. (See Figure 14.)

a Injured passengers being helped out the end of the car and down to the ground after having climbed over partitions and through the 2-foot high tunnels over or under the rest rooms

b Some were rescued by being lifted up through windows by means of ropes

c Other rescue workers brought ladders to assist passengers to the ground after they climbed up the seats and out the windows

d View of rescue workers lowering a ladder through a window they have knocked out to rescue passengers
