PB94-916301  
NTSB/RAR-94/01

# NATIONAL TRANSPORTATION SAFETY BOARD

## RAILROAD-MARINE ACCIDENT REPORT

DERAILMENT OF AMTRAK TRAIN NO. 2  
ON THE CSXT BIG BAYOU CANOT BRIDGE  
NEAR MOBILE, ALABAMA  
SEPTEMBER 22, 1993

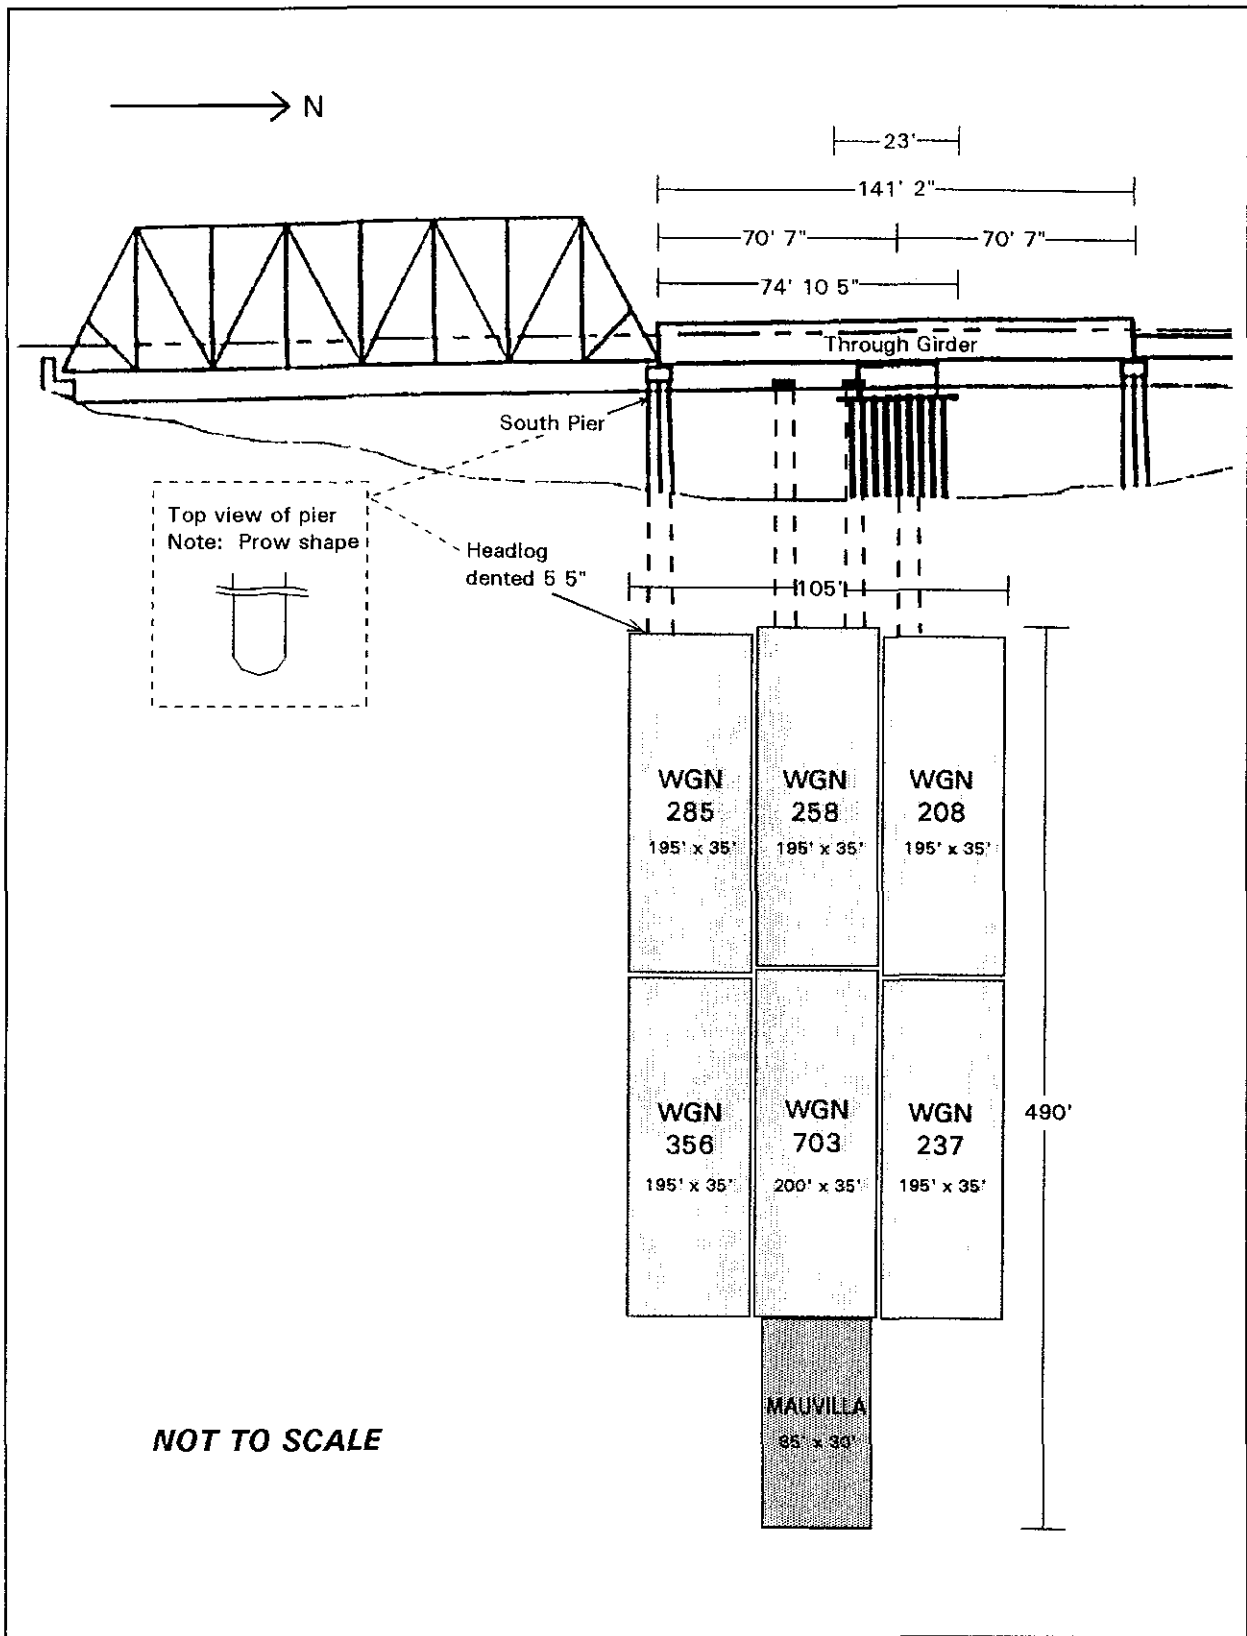
Figure 4.--MAUVILLA tow configuration and Big Bayou Canot bridge.

was drydocked at W&GN's yard on September 27, 1993, for a hull survey. The marine investigative group noted no apparent damage to the hull, rudders, or propellers. Inspection revealed no evidence of a wire or other item having been wrapped around the propellers or rudders. The lead port (WGN 285) and starboard (WGN 208) barges (see figure 8) were slightly dented where they struck the bridge's concrete piers, and the center lead barge (WGN 258) had six marks on its headlog where it struck the vertical stiffeners on the bridge span (see figure 4). The other three barges were undamaged.

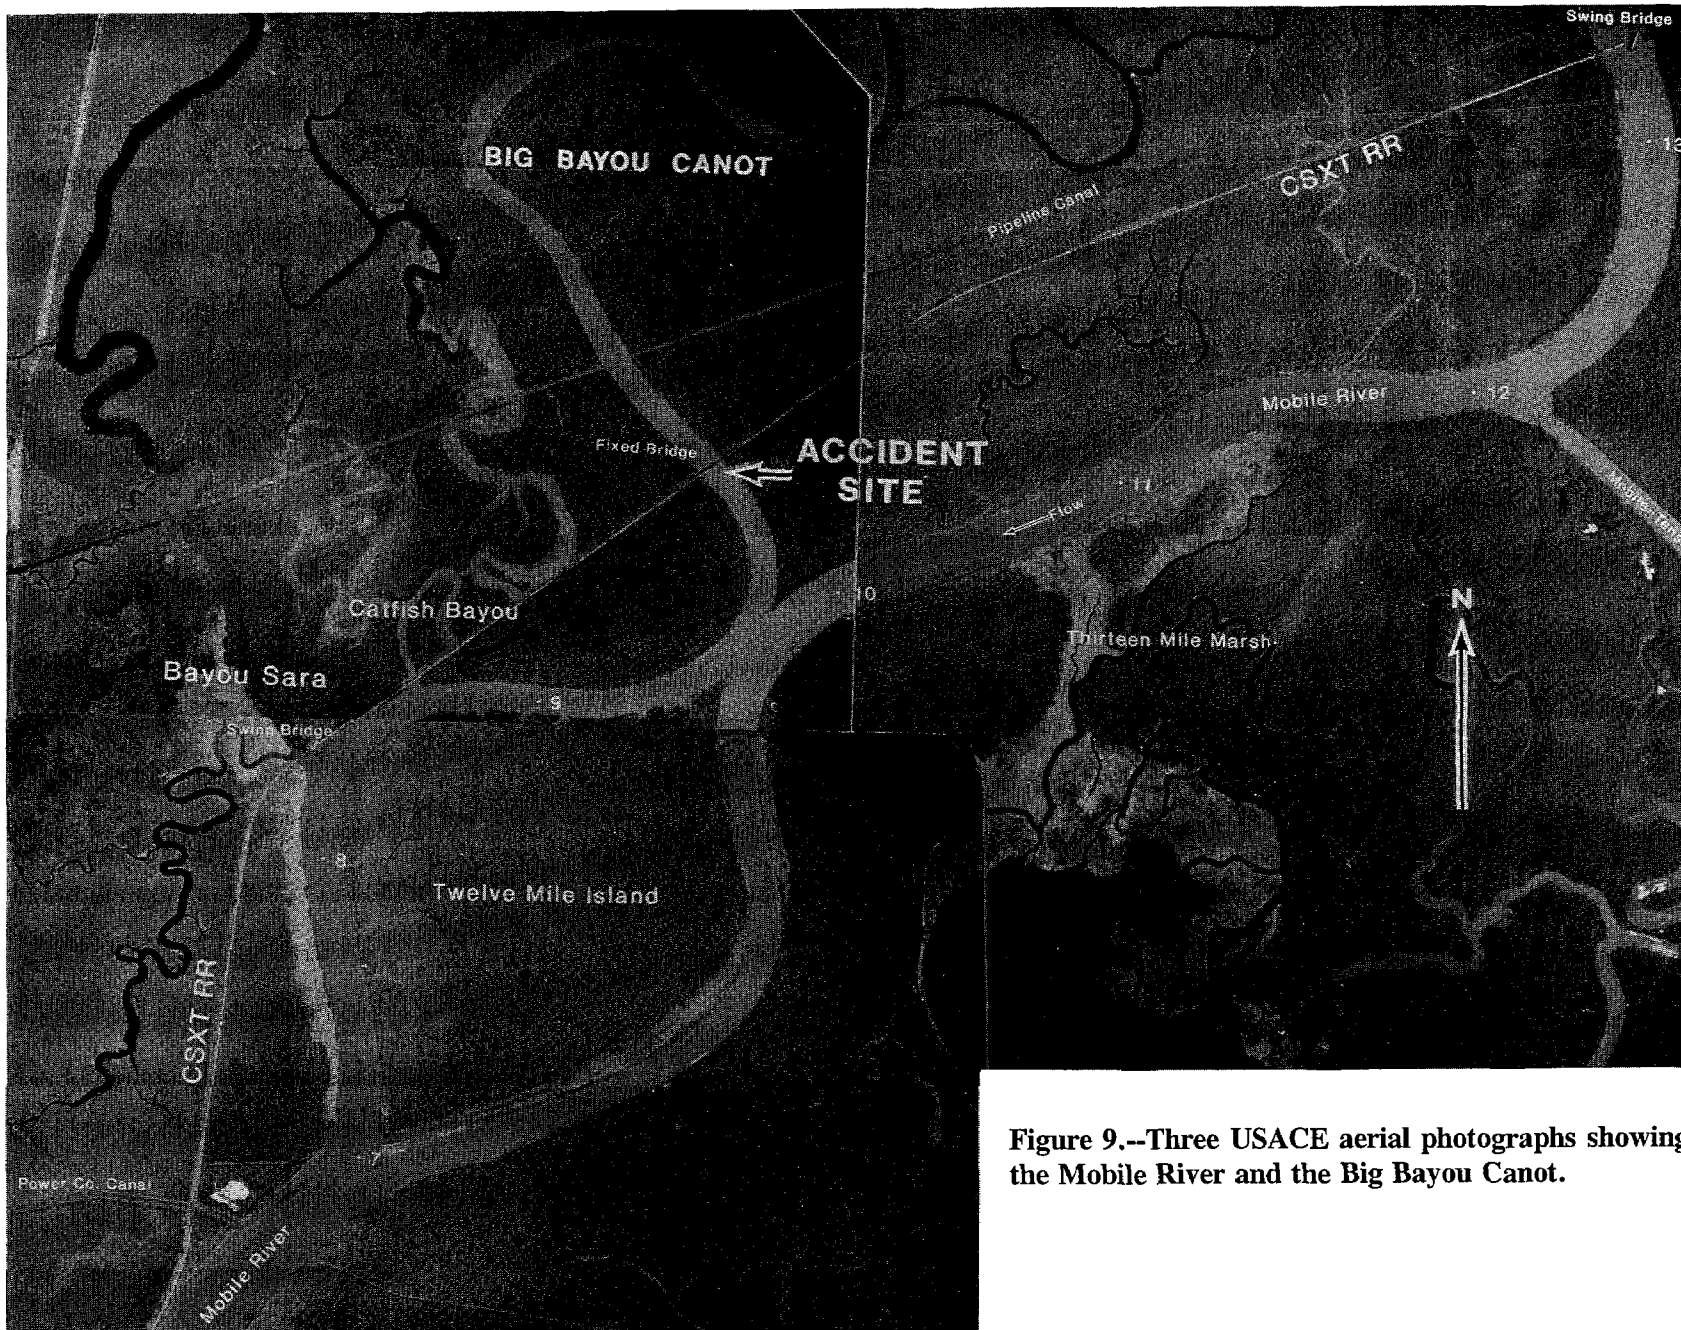
Figure 9.--Three USACE aerial photographs showing the Mobile River and the Big Bayou Canot.

To continue upriver and avoid entering the Big Bayou Canot, a tow following the river curvature must stop its leftward movement (see figure 9). When the shorelines are visible, cues are available to guide an operator through the intersection. When the shorelines are obscured, an operator needs radar information to stay on the intended courses. He or she has to correlate the radar information with chart information or memory of the waterway's geography to determine the tow's location and choose the proper waterway.

The radar presentation varies as the tow proceeds, and the images must continually be interpreted because the outlines may differ from those shown on charts or sighted visually. The pilot either did not observe the radar sufficiently to obtain the information available, was inadequately trained to understand what the radar presented, or both. He testified that after receiving his license, W&GN "trained me as a copilot for almost a year, I believe. I went through to copilot training. That's learning how to operate the boat, running the rivers, and how to operate the radar." The pilot said he learned how to use radar through "on-the-job training," noting that he had not operated the type or model of radar on the MAUVILLA but had been exposed to and operated other models. He testified that he had received no formal training in the use and interpretation of radar. "Not going to school. Not for radar, no."
